## 目录

## 1、解压 SDK

源码路径：ISVP-T40-1.1.1-20220120\software\sdk\Ingenic-SDK-T40-1.1.1-20220120\opensource

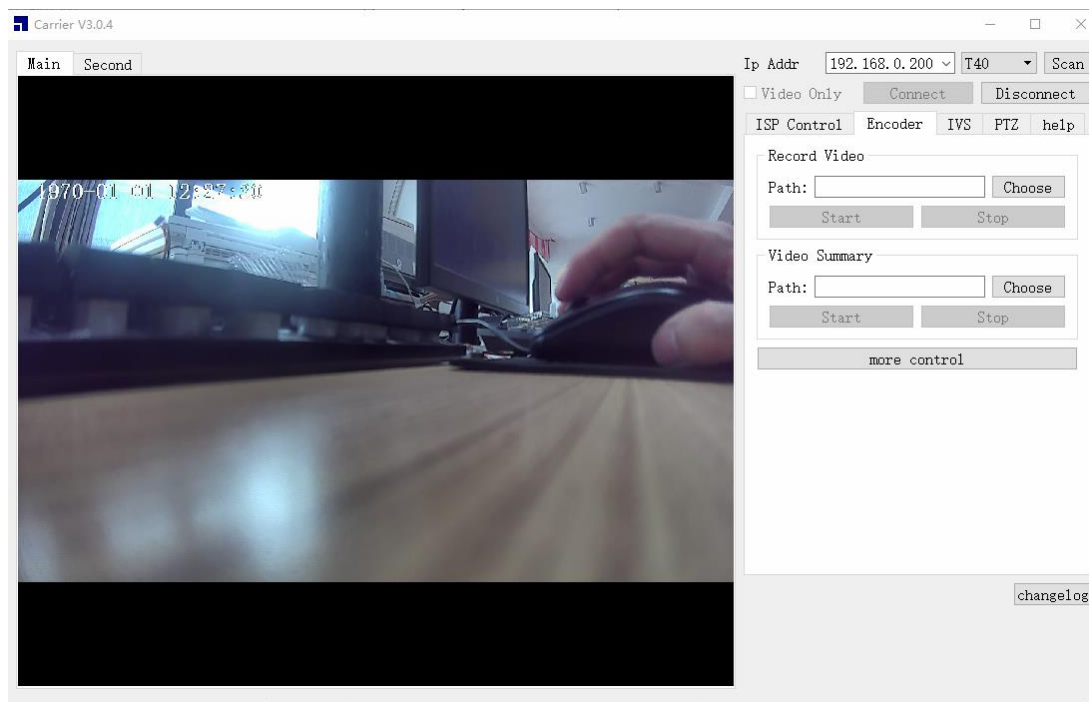
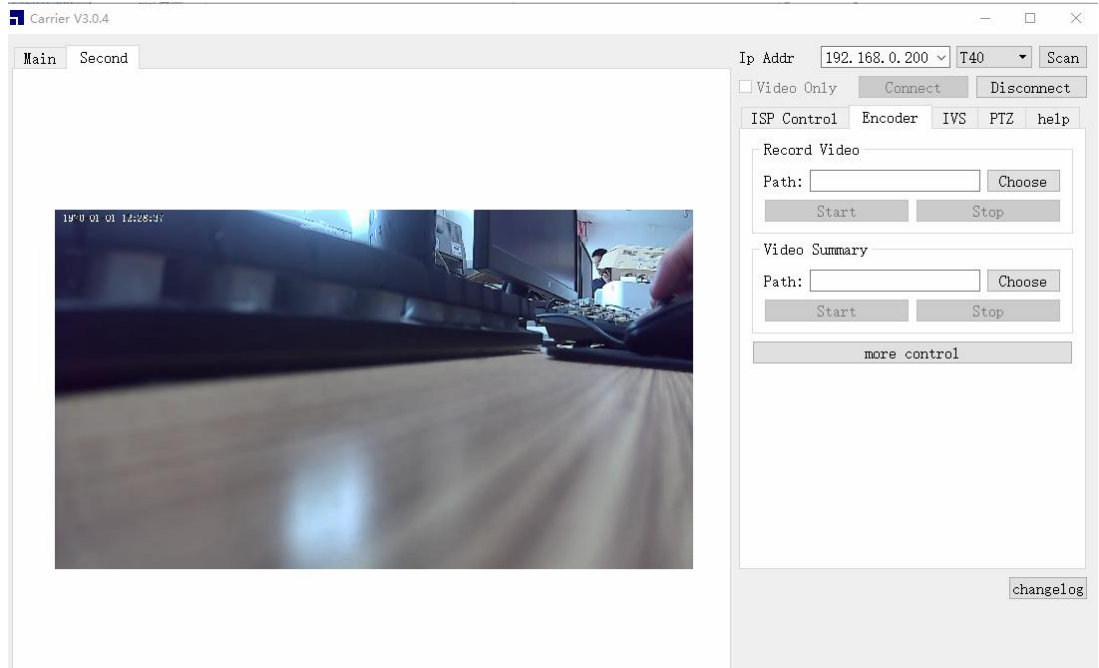
(3) 尝试重新打开 carrier 软件  
 正常情况 main 页和 sencod 页都有图像:
